Manhole Inspection Summary

Manhole # S25II_039MH

Insp Date: **8/29/07 9:56 AM**

Location Address: **2027 DRUID HILL AVE**

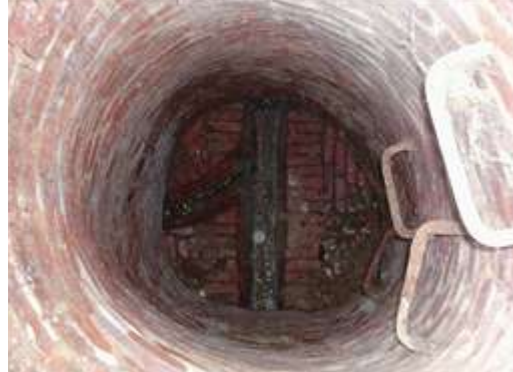
Top View

Barrel infiltration. Corroded and missing steps. Bench debris.

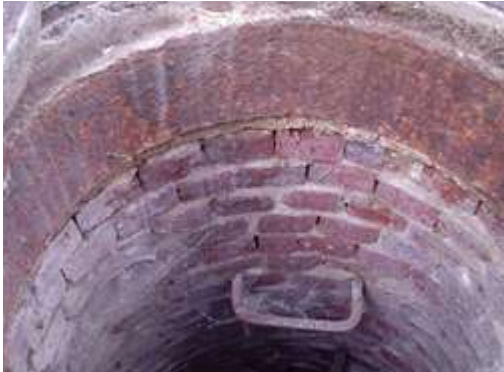
Defect

Frame leaks. Adjustment and Corbel deterioration and infiltration. Barrel infiltration.

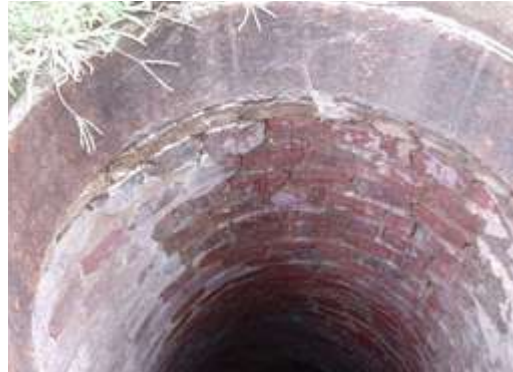
Defect

Frame leaks. Adjustment deterioration and infiltration. Corbel and Barrel infiltration.

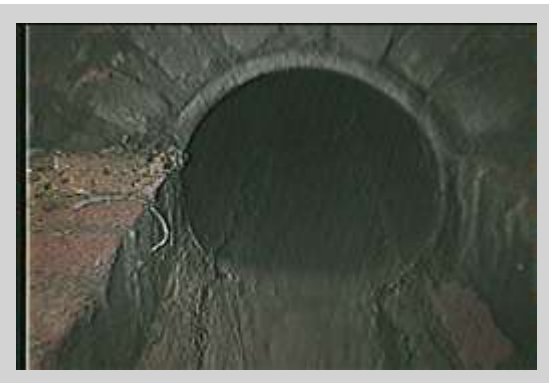
10 in. Circular Gravity Sewer Pipe In @ 6 O'Clock

Infiltration: **Evidence** Pipe Seal Cond: **Unknown**

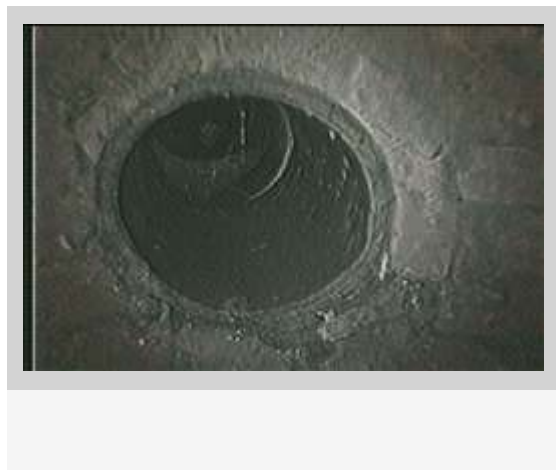
Pipe In @ 8 O'Clock

Infiltration: **Evidence**
